What Should Aviation Safety Incidents Teach Us?

William S. Greenwell John C. Knight

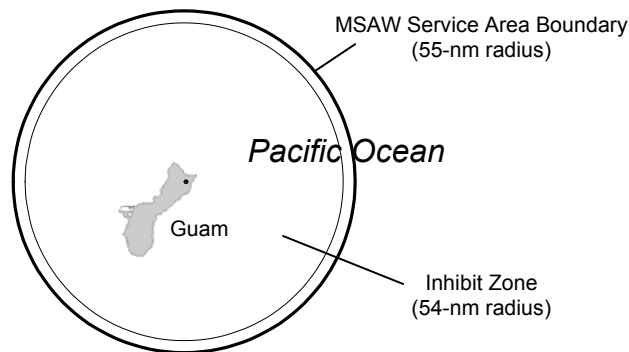
Fig. 1. The Guam MSAW inhibit zone (not drawn to scale)

According to the NTSB report, the Guam MSAW system was installed in 1990 and originally configured to monitor an area within a 55-nautical mile (nm) radius of the Guam radar. In March 1993, Guam air traffic managers, in conjunction with the FAA's Western-Pacific Region office and the FAA Technical Center, prepared new site adaptation parameters for the Guam MSAW system that included a 54-nm inhibit zone centered at the Guam radar site as illustrated in Figure 1. According to NTSB investigators, this change was "neither a fluke nor a malfunction but rather was an intentional adaptation change for the purpose of eliminating numerous nuisance low altitude alerts," and was put in place "for temporary use until a better solution to the problem of nuisance alarms could be found" [4]. According to testimony from the acting manager of the National Field Support Division (NFSD) of the FAA Technical Center at the time of the accident, this change effectively reduced MSAW processing to a 1-nm ring located between 54 and 55 nm from the radar facility as shown in Figure 1. No general or approach path warnings would be generated by the system for aircraft operating within the inhibit zone [2].

After the accident, the FAA and NTSB investigators conducted a simulation of Korean Air flight 801's final approach with the MSAW inhibit zone removed. The simulation indicated that, without the inhibit zone, the MSAW system would have generated visual and aural low altitude warnings for KA 801 64 seconds prior to impact. The NTSB concluded in its report that this would have been sufficient time for air traffic controllers to notify KA 801 and for the flight crew to take remedial action.

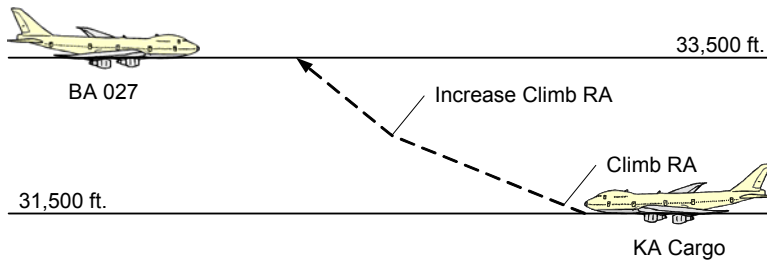
The TCAS unit installed on the Korean Air jet indicated traffic 400 feet below and approaching head on and shortly thereafter instructed the pilot to climb to avoid the oncoming traffic. In reality, there were no other aircraft in the vicinity of the Korean Air jet except for the British Airways flight 2,000 feet *above*, and the TCAS unit's indication and climb instruction were erroneous. The pilot had no way of knowing this, however, as he was operating in a region of airspace without air traffic control service and the cloud layer severely limited his visibility, and thus he followed the climb instruction issued by TCAS. The Korean Air pilot reported that the vertical separation between his aircraft and the phantom aircraft indicated by TCAS decreased to zero before increasing, and before reaching zero TCAS instructed him to increase his rate of climb. The pilot complied and pitched his aircraft further, unknowingly placing it on a collision course with British Airways flight 027, which was now closing in rapidly from above as shown in Figure 2 [7, 8].

Fig. 2. British Airways flight 027 incident sequence

Although the air data source was sending the correct altitude value, the bit-stuck-at-one error on the data line caused TCAS to receive a value containing a one-bit discrepancy that corresponded to a 2,400-foot difference in altitude according to Gillham code [7]. Thus, the TCAS unit aboard the Korean Air jet believed it was flying at 33,900 feet, placing it 400 feet above the British Airways jet. According to the separation rules used by TCAS, this created a conflict between the two aircraft, and since TCAS believed it was the one on top, it issued a climb resolution advisory (RA) to the pilot. As the pilot executed the instruction and the aircraft's altitude began to increase,

the altitude value reported to TCAS also changed; however the one-bit error caused TCAS to think the aircraft was actually descending, decreasing the separation between it and the intruder. This led the system to revise its RA and instruct the pilot to climb faster, placing the two aircraft on what was actually a near-collision course.

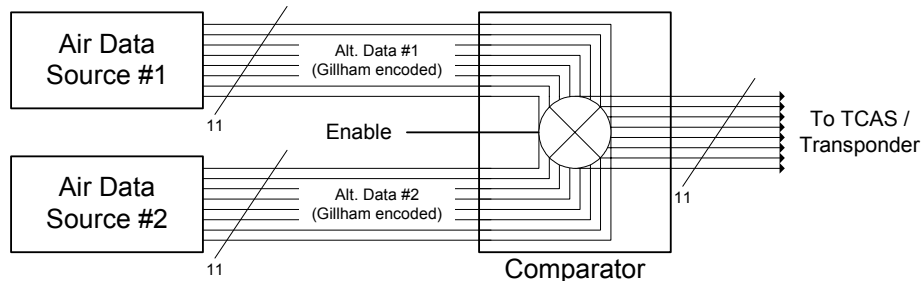
TCAS receives flight data for the aircraft on which it is operating from two independent air data sources. These data are passed into a comparator where they are averaged before being sent to the TCAS logic unit as illustrated in Figure 3. If the comparator detects that the variance in the inputs from the air data sources is too large, it raises an error signal that prompts TCAS to shut down and print an error message on the primary flight display. This design allows the system to detect but not tolerate disagreement between the air data sources or a failure of one of the sources. The comparator on the TCAS unit installed in the Korean Air Cargo jet featured an Enable line that if set to one would cause the comparator to function normally and if set to zero would

Fig. 3. Simplified schematic of the air data comparator

The second issue pertains to the design of the comparator used to verify the data gathered from the two air data sources. The purpose of receiving data from two separate sources is to stabilize the air data TCAS receives and reduce the likelihood that faulty data is allowed to pass into TCAS undetected. The dependability increase achieved through this fault detection mechanism is defeated, however, if the compara-

tor itself introduces vulnerabilities into the system. In the design used by the TCAS unit aboard the Korean Air jet, the Enable line to the comparator presented such a vulnerability.
