The Case of the Lakewood "Hi-Stak"

Failure of a Stacking Hoist

On May 23rd, 1994, West Michaels, an employee of the Buchanan Company, a large construction vehicle manufacturer, had an accident and was seriously injured while operating a "Hi-Stak" crane. The crane had been purchased from the Lakewood Company, a large manufacturing firm, which had designed, manufactured, and sold hundreds self-contained storage/retrieval systems.

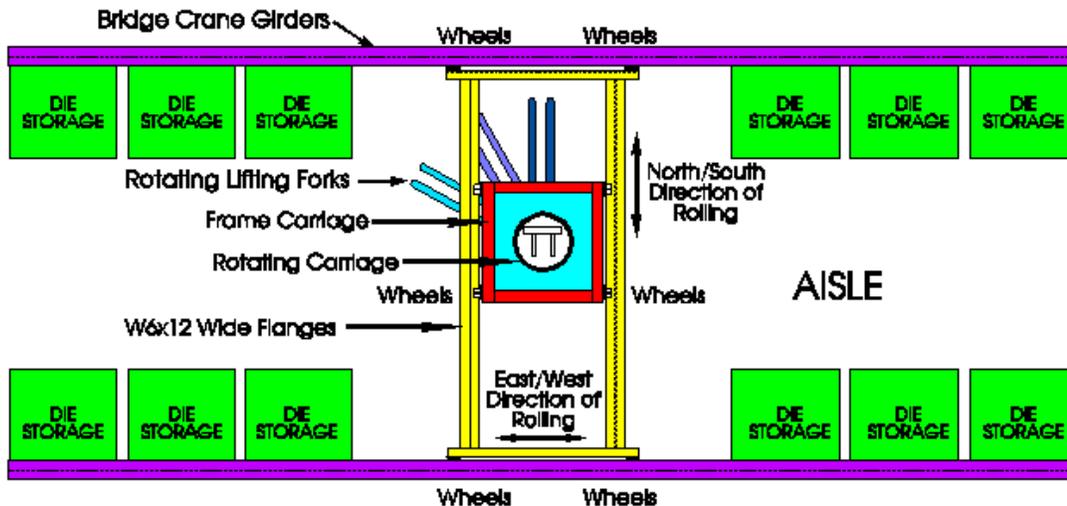
Figure 1

The Lakewood Company, a fairly large manufacturing firm, has designed, manufactured and sold hundreds of self-contained storage/retrieval systems which are used for storing heavy parts such as dies, which must intermittently be taken from storage and used elsewhere in the plant. The system consists of two large sets of storage racks, facing each other, with an integral crane that runs between them on 2 bridge crane girders on the top back edges of the storage racks (see Figure 1).

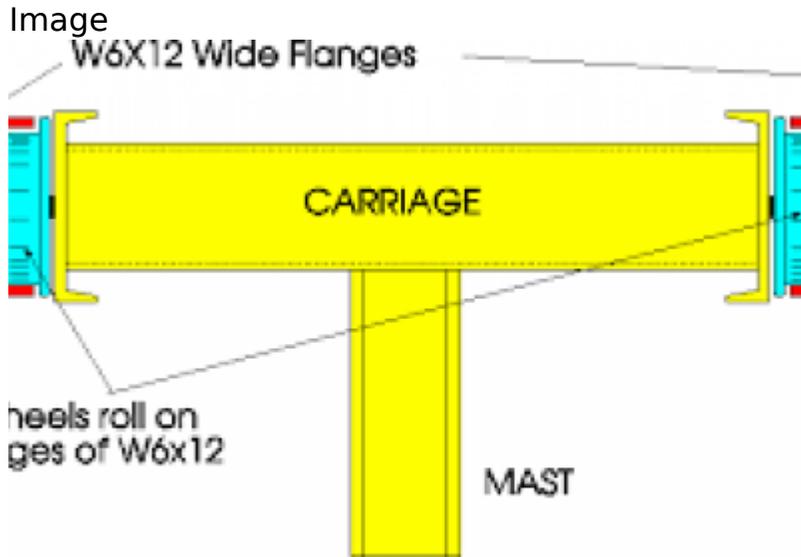
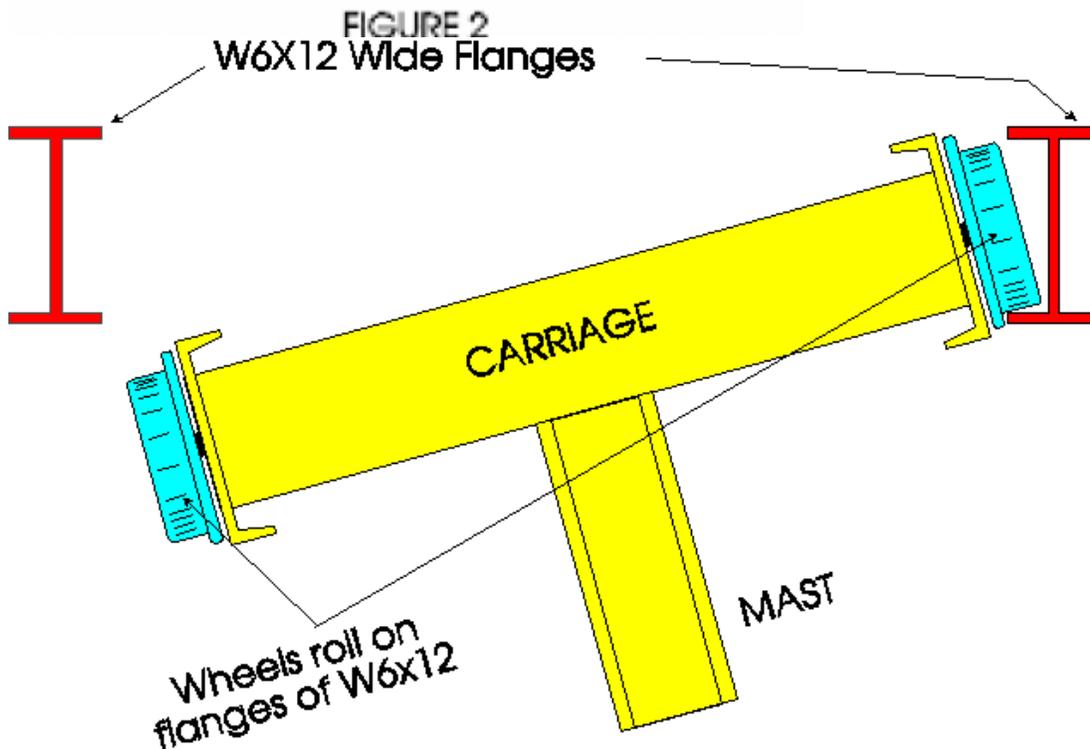
FIGURE 3

The accident caused the crane wheels on the back side of the pallet to be pulled free of the lower flange of the A588 steel W6X12 girder on the left side. (See Figures 2 and 3).

2. 10 am - I went to HH20E to investigate the accident. The crane trolley had slipped out from between the two crane girders and fell to the shop floor. The load was high above the floor and behind the south girder at time of failure. The evidence at the accident scene indicated that two trolley wheels had slipped off the south girder first. The weight of the load caused the trolley mast unit to pivot about the front girder. The mast swung up striking Mr. Michaels and throwing him about 20 feet north. Fortunately, he was thrown clear of the falling equipment. See also my notes on physical dimensions taken of crane unit, and photographs taken at the scene of the accident.

problem is the equivalent 813 pound lateral load on the W6x12 wide flange, which bends the section about its weak axis. The wide flange is overstressed by 3.29 to 1.

girder bottom flange should be reduced or the girder must also be reinforced for lateral stability. Safety lugs mounted on the trolley unit and over the crane girders should also be installed. Lakewood will design the changes and obtain our agreement on the design. Buchanan HH Facilities Services personnel will make the changes at the direction of Lakewood's serviceman.

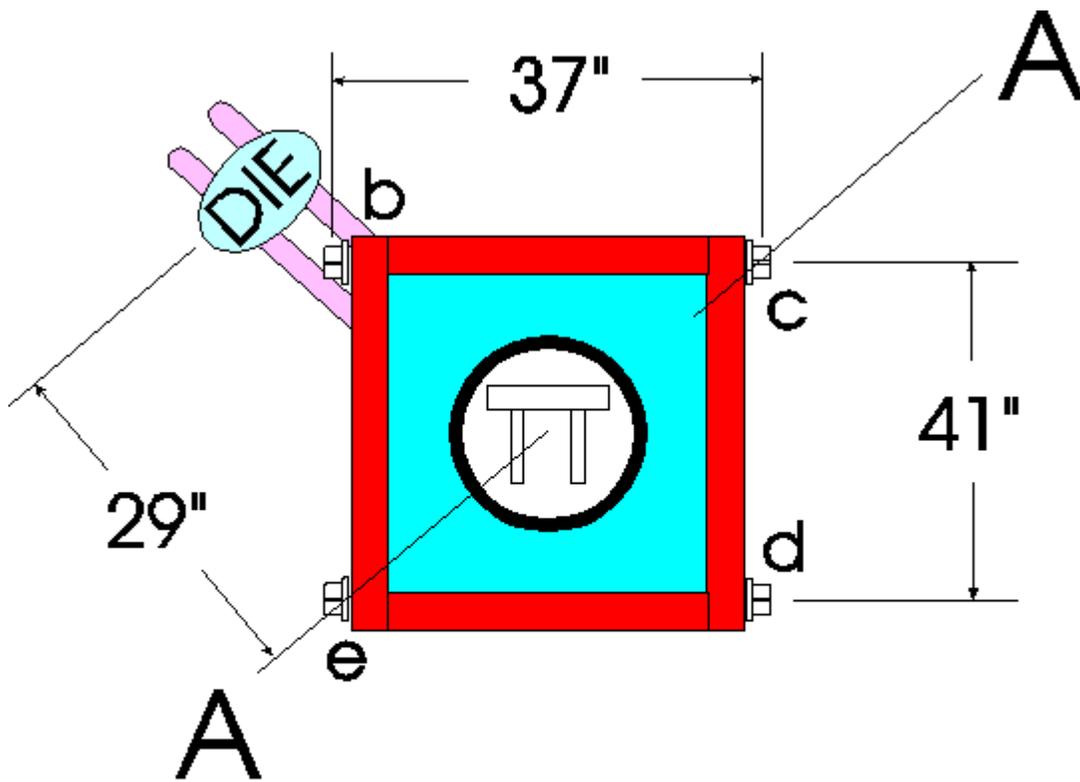
Figure 8

The maximum loading on the W6x12 beam is realized when the pallet and die are rotated directly over one of the carriage wheels, as shown above.

The die and pallet live load rating is 2000 pounds, and can be up to 29 inches from the center of rotation of the crane. The dead load of the crane itself is 1875 pounds, and is located at the point of rotation of the crane. Using AISC-LRFD design procedures, the factored live load, including a 10% allowance for impact (Section A-4.1 and A-4.2) is

Moment about line A-A = $3520\# \times 29" = 102.080$ in lbs, which must be resisted by wheels b and d. Since these wheels are on the hypotenuse of a triangle, they are $[(41/2)^2 + (37/2)^2]^{0.5} = 26.6$ inches from the center of the crane.

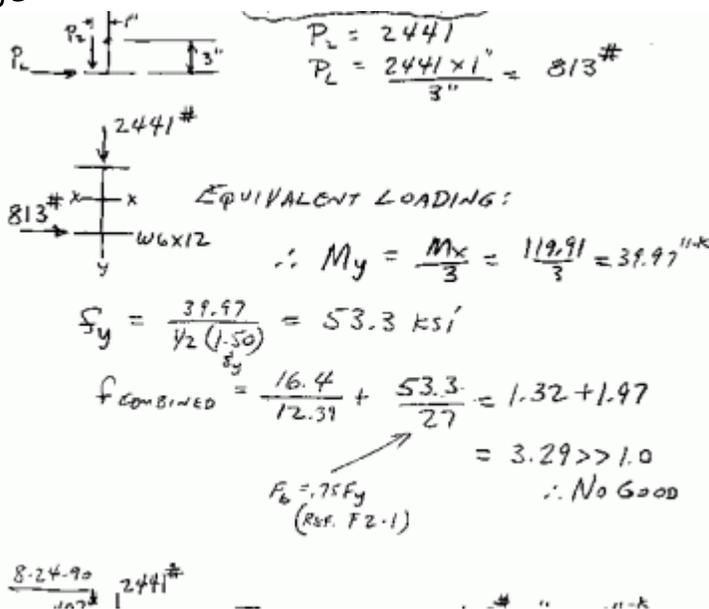
P2 is the maximum calculated wheel load, which is 1" off-center. PL is the equivalent lateral load which gives the same torsional twist to the beam as did P2, when P2 is moved to a direct shear position. This lateral load causes significant bending about the weak axis of the beam, as shown in the calculations below.
