Spatial Audit: Charlottesville Parks

PLAN 6020 Methods of Community Research and Engagement

Fall 2018

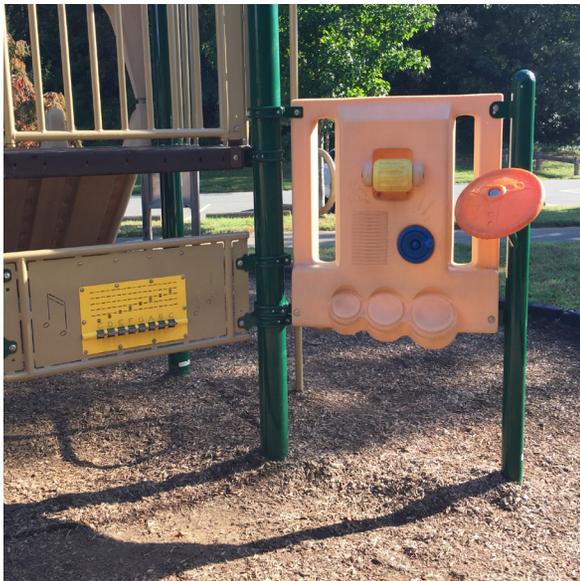
Though on mulch, there are two inclusive play components: music key notes and bongo drums

Out of Azalea Park's two separate playgrounds, its independent structure was limited to one wall of sensory material, which included drums and musical key notes. We considered the other structures to be too tall for a user in a wheelchair, so the steering wheel and spinning wheel did not count towards this. Each playground had a plastic curb around the perimeter, with a ramp leading into the playspace. However, the ground material is mulch which could be inaccessible.

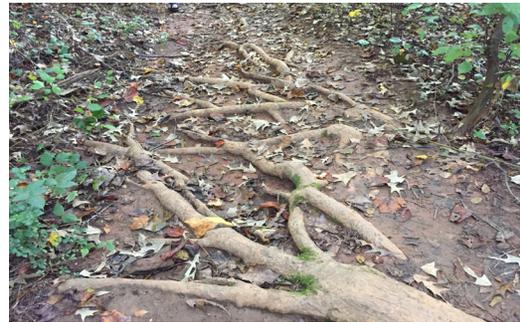
Roots and mud make on-site trail inaccessible

Despite being one of the larger parks in Charlottesville, Azalea Park faced some issues with access to some of their distinct features. The basketball court, which could be considered one of the more inclusive spaces as paved, open space, lacked a path to the area. The park is also connected to the Rivanna Trail, which was highly inaccessible with overgrown tree roots, steep inclines, and mud.

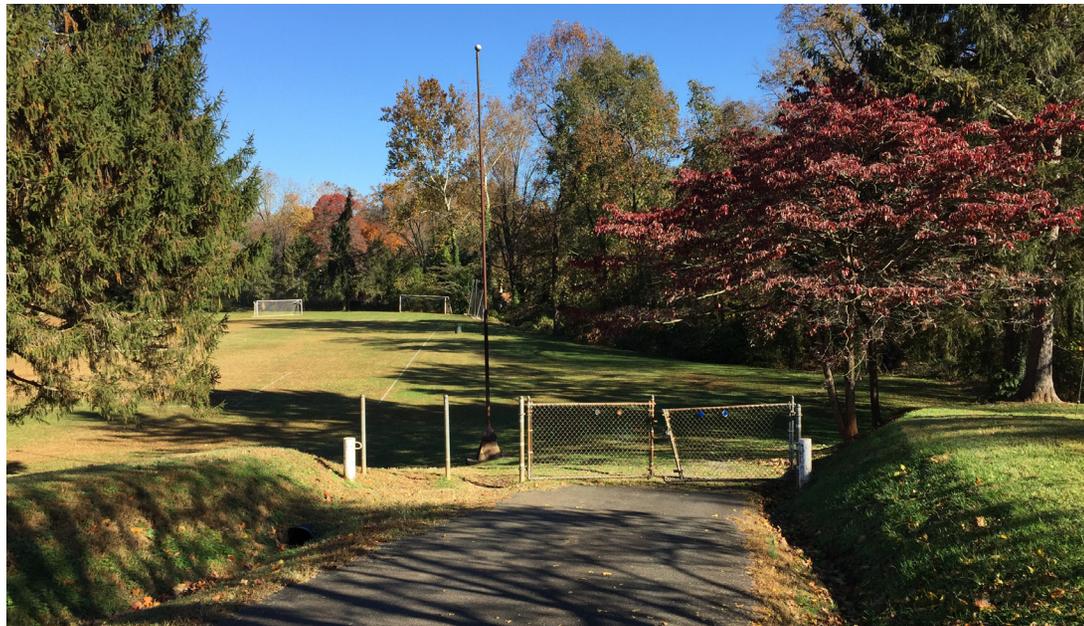
Barriers and slop at the entrance

Because it's a small court in the community, there is no parking lot, and cars can only park along the street. Besides that, a closed gate at the entrance of the court exist, which would prevent the wheelchairs but not pedestrians. There is not any play structure, so children with limited mobility cannot have fun here at present.

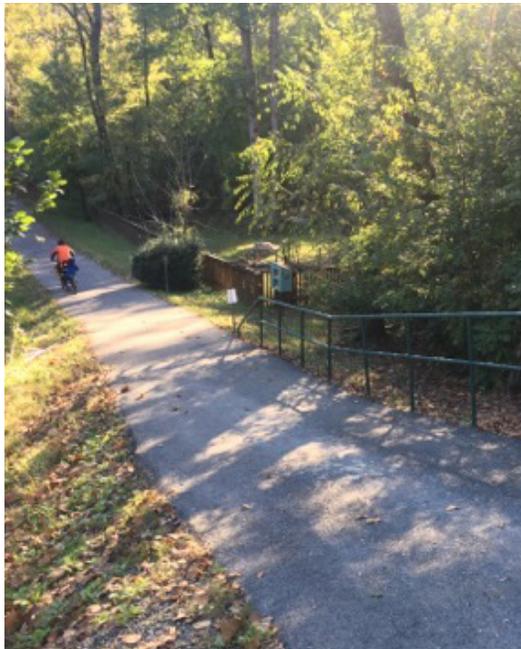
Steep Entry Ramp

Parking is limited and constrained to a nearby cul-de-sac and parallel street parking, with no designated ADA spots available. but are limiting in their grades and steep drop offs which pose a major risk to accompanied visitors with assisted mobility limitations.

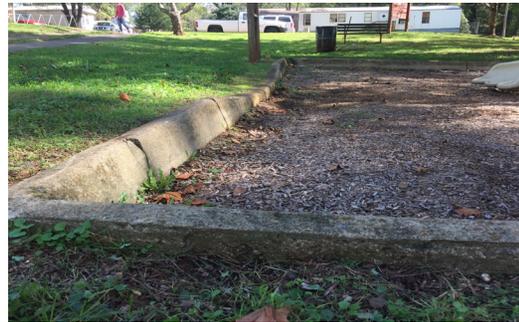
Barrier: playspace boundary drops

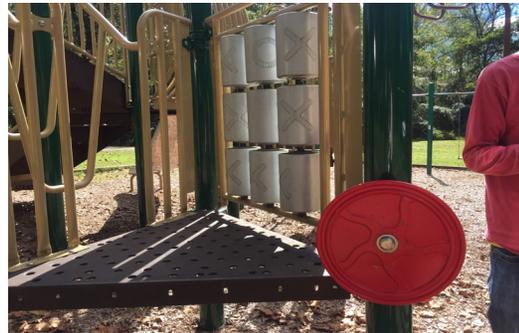
Steering wheel is the one accessible play component

The key asset of Jordan Park would likely be the creek and the adjacent open space. However, if a limited mobile individual does not live in the neighborhood, the challenges of accessible parking and limited amenities may pose as a barrier that outweighs the benefits of the park. The one independent play structure was a steering wheel attached to the playground. However, it is questionable whether it would be worth it to even enter the playground, which has a four-inch drop, to play with this one steering wheel.

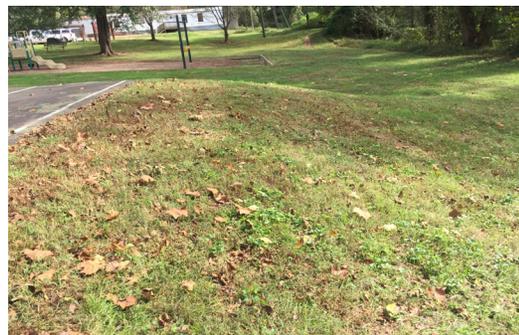
Basketball court has a steep slope down towards the open field

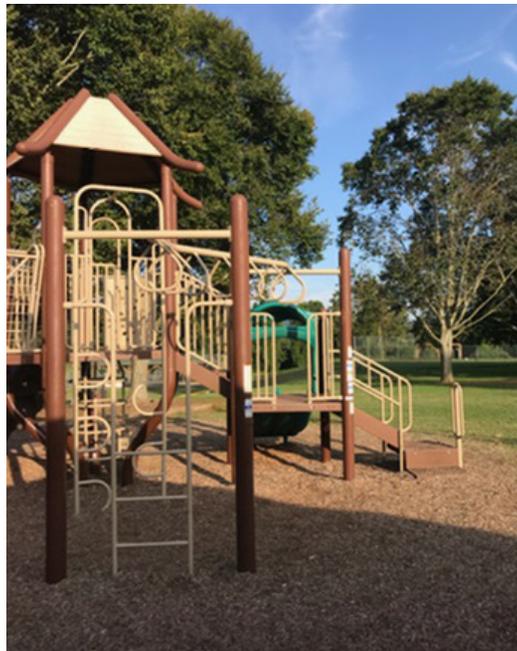
No Inclusive play structures

The playground did not contain inclusive play structures. The play structure was primarily vertical and did not offer many interesting or fun aspects on the ground level. Assistance would be a necessity in order for a child with mobility challenges to access the structure. The trail is poorly maintained, very steep, not paved fully, and would pose a major risk to a wheelchair user. There was no water fountain present at the main pavilion.

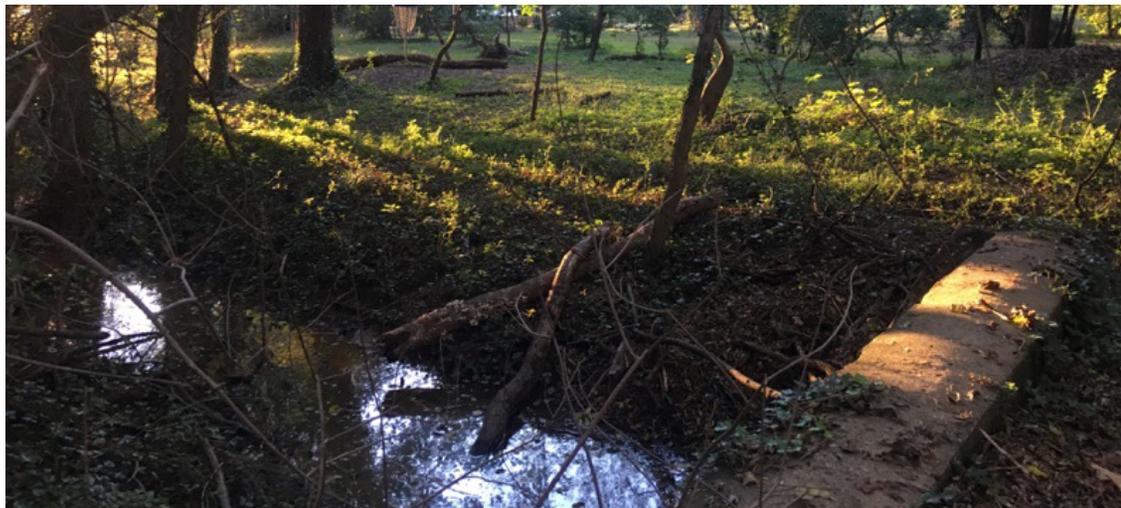
Trail over a creek

The disc golf course and trails are not accessible as they are contained within a heavily wooded portion of the park and requires players to weave between trees and other natural obstacles (stumps, roots, rocks, etc).

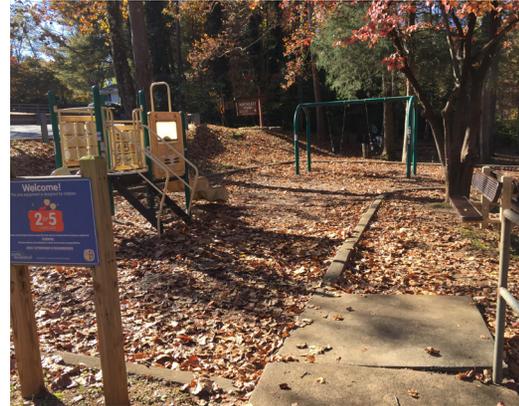
Inaccessible to the play structures

There are several play structures but accessing to all the play structures needs assistance, and the area of play structures are surrounded by steps which are normal for ordinary people but barriers for wheelchairs. The key assets of Davis field are its location close to the public transportation, but buses in Charlottesville are not accessible for wheelchairs at present. We believe that public transportation in the future would also develop to be more inclusive and accessible.

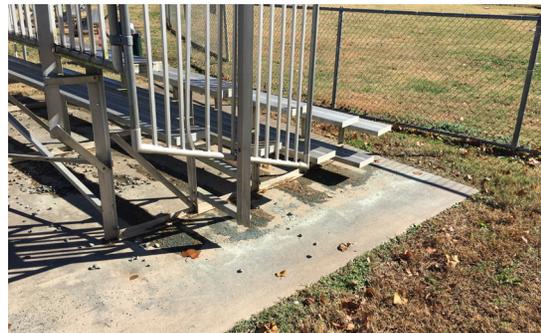
This park has one ADA designated parking space with an access aisle, but the slope of the parking lot in this area as well as the cross slope of the adjacent curb-cut ramp were too steep. The path leading from the parking lot also has a steep decline and changes from asphalt to gravel. There were also concrete pads with bleachers for viewing the baseball field, but there was not space provided for a wheelchair to sit on these concrete pads.

Missing accessible space for wheelchair

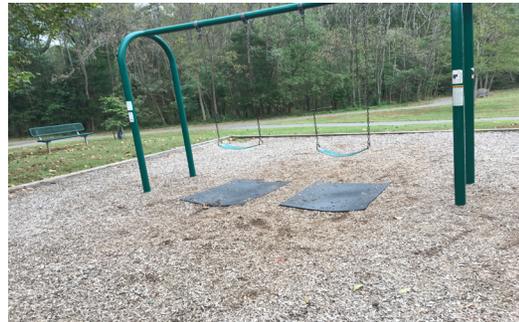
Inaccessible swing set with mulch

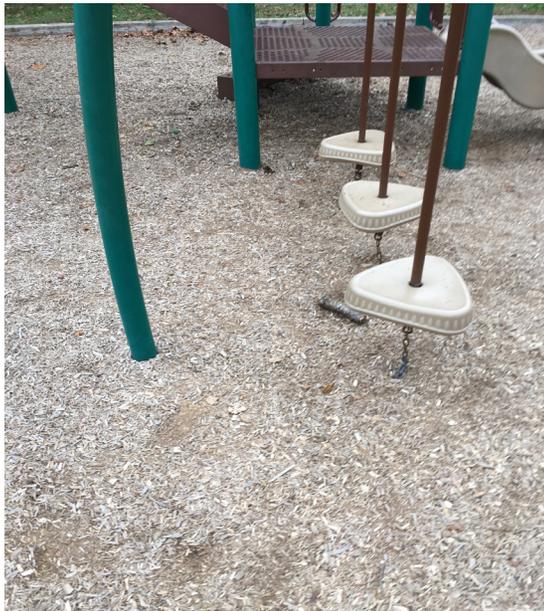
Inaccessible play components on mulch

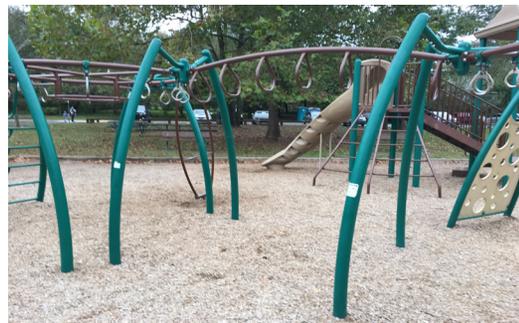
Inaccessible play components on mulch

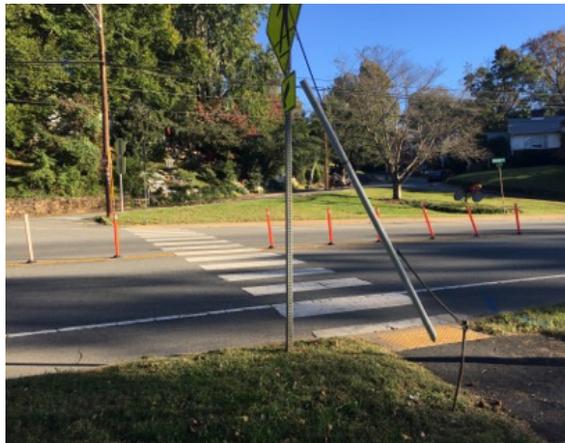
Crosswalk across busy road

The greenway is only accessible by car and there is not a designated parking area adjacent to the park. Street parking is the only option available to park-goers and they must cross a busy thoroughfare in order to access the park. There is significant road noise during rush hour. Finally, this park contains no play structures.

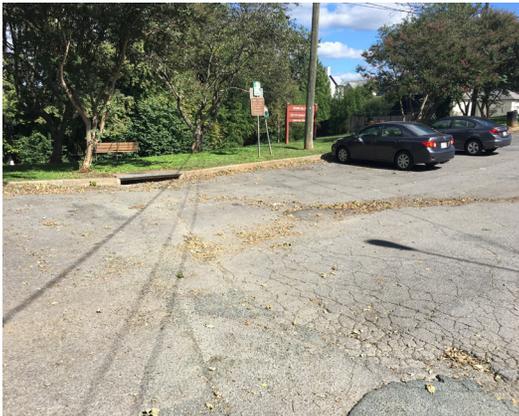
Starr Hill Park was one of the lowest-rated parks. It is relatively inaccessible, with no ADA spaces, no curb cuts, and a steeply graded lot from the adjacent neighborhood to the greenspace. While the path from the neighborhood to the park is paved, it had a sharp incline, which could pose as a challenge.

Parking lot with no ADA spaces with a steep grade

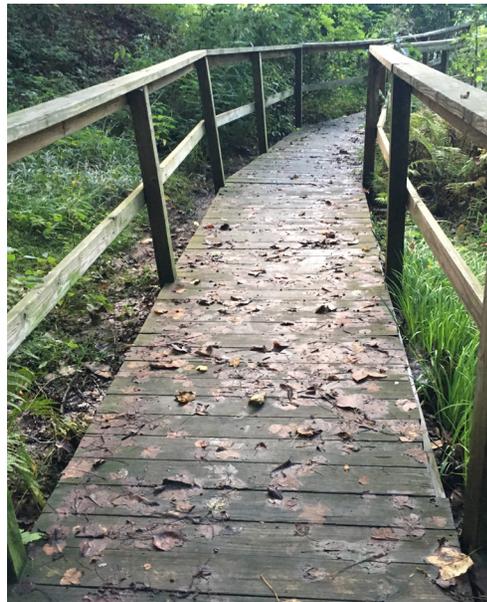
Inaccessible trail

Areas of vegetation overgrowth into path area may act as a barrier to wheelchair use of the trail. There is a steep, paved path leading from the parking lot to the upper park that would be difficult to maneuver with a wheelchair. There are no inclusive/ accessible play components as the play structure is primarily vertical in nature. The swing set and playground have a mulched ground surface that prohibit children in wheelchairs or walkers from easily accessing the play structures. The grassy area by the pavilion does not provide enough room for running games with a power wheelchair, thus limiting children from playing together. The trail on the site is inaccessible for users in a wheelchair.

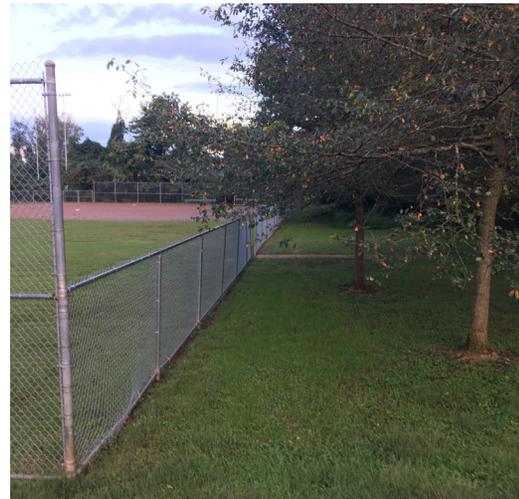
Poor access to baseball diamond
