# The Space Shuttle Challenger Disaster

A case study looking at the explosion of the Challenger Space Shuttle.

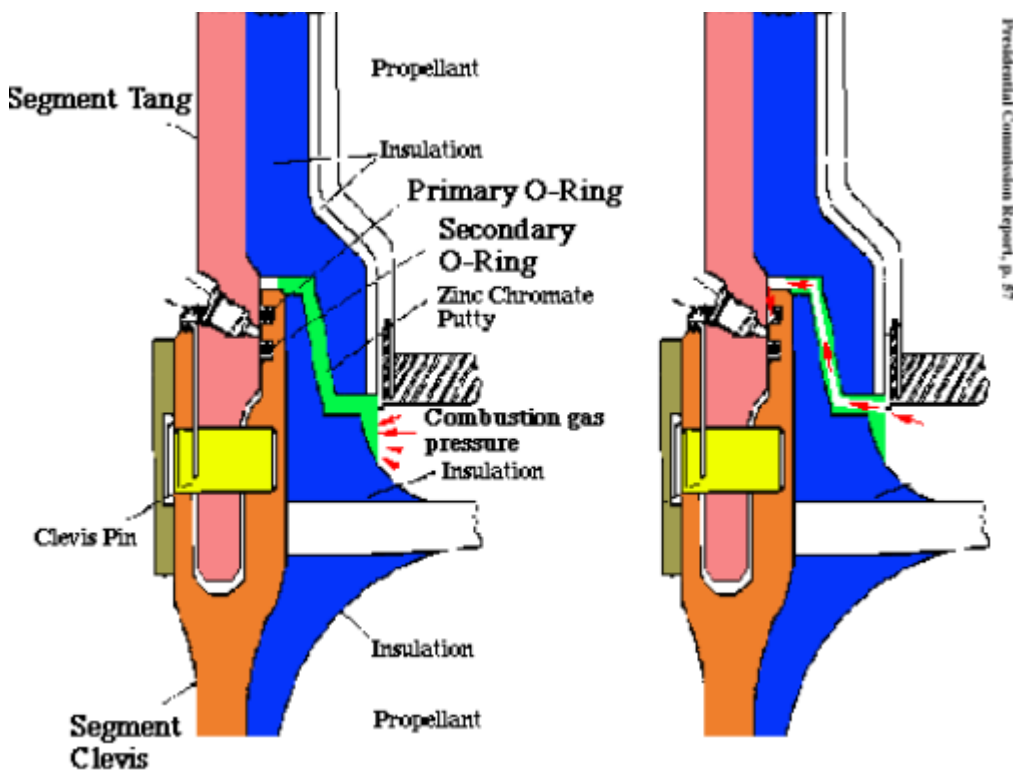
There is an SRB attached to each side of the external fuel tank. Each booster is 149 feet long and 12 feet in diameter. Before ignition, each booster weighs 2 million pounds. Solid rockets in general produce much more thrust per pound than their liquid fuel counterparts. The drawback is that once the solid rocket fuel has been ignited, it cannot be turned off or even controlled. So it was extremely important that the shuttle SRBs were properly designed. Morton Thiokol was awarded the contract to design and build the SRBs in 1974. Thiokol's design is a scaled-up version of a Titan missile which had been used successfully for years. NASA accepted the design in 1976. The booster is comprised of seven hollow metal cylinders. The solid rocket fuel is cast into the cylinders at the Thiokol plant in Utah, and the cylinders are assembled into pairs for transport to Kennedy Space Center in Florida. At KSC, the four booster segments are assembled into a completed booster rocket. The joints where the segments are joined together at KSC are known as field joints (See Figure 1).

These field joints consist of a tang and clevis joint. The tang and clevis are held together by 177 clevis pins. Each joint is sealed by two O rings, the bottom ring known as the primary O ring, and the top known as the secondary O-ring. (The Titan booster had only one O-ring. The second ring was added as a measure of redundancy since the boosters would be lifting humans into orbit. Except for the increased scale of the rocket's diameter, this was the only major difference between the shuttle booster and the Titan booster.) The purpose of the O-rings is to prevent hot combustion gasses from escaping from the inside of the motor. To provide a barrier between the rubber O-rings and the combustion gasses, a heat resistant putty is applied to the inner section of the joint prior to assembly. The gap between the tang and the clevis determines the amount of compression on the O-ring. To minimize the gap and increase the squeeze on the O-ring, shims are inserted between the tang and the outside leg of the clevis.

The air pressure forces the O-ring into the gap between the tang and clevis. Pressure loads are also applied to the walls of the cylinder, causing the cylinder to balloon slightly. This ballooning of the cylinder walls caused the gap between the tang and clevis gap to open. This effect has come to be known as joint rotation. Morton-Thiokol discovered this joint rotation as part of its testing program in 1977. Thiokol discussed the problem with NASA and started analyzing and testing to determine how to increase the O-ring compression, thereby decreasing the effect of joint rotation. Three design changes were implemented:
