Case 1: Fire by Sodium Coolant Leak at Prototype Fast Breeder Reactor, Monju

Case 1 of Teaching Case Studies of Accidents in Nuclear Energy Development in Japan describes a fire caused by a massive sodium coolant leak at the Monju fast breeder reactor.

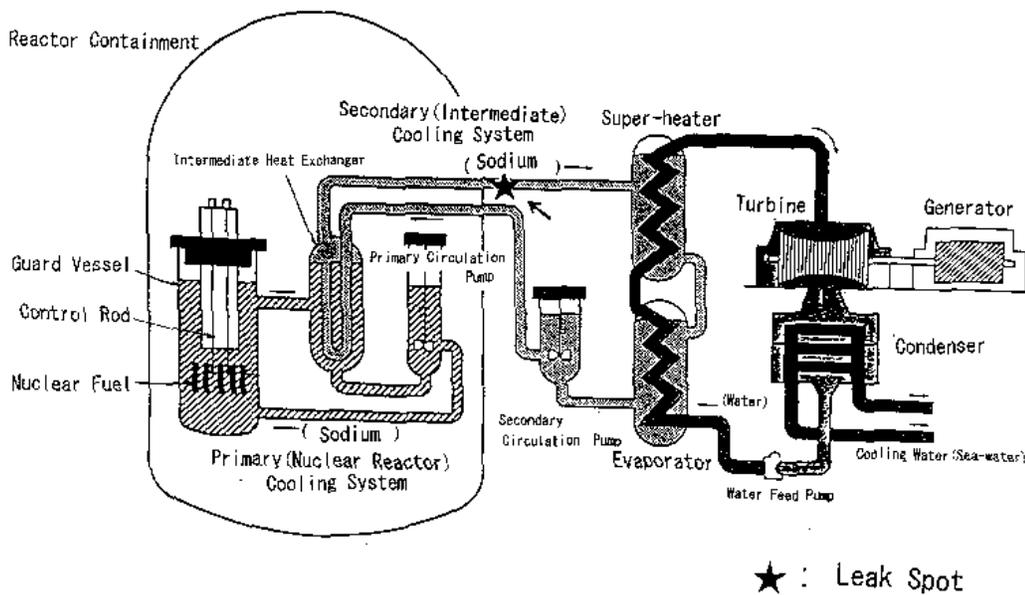
Figure 1:

Schematic Diagram of Prototype Fast Breeder Reactor, Monju

On December 8, 1995, a prototype fast breeder reactor, Monju, located in Tsuruga City, 350km west of Tokyo, was operating at 40% power⁽²⁾. The Power Reactor and Nuclear Fuel Development Corp (PNC), a government controlled organization, operated this reactor. At 19:47 high temperature liquid sodium coolant at one of the three secondary heat exchangers started leaking through a broken thermometer sheath (designed by IH Company, OD: 10mm, ID: 4mm, Length: 150mm) on the piping and it ignited on contact with air. As shown in Fig. 1, the primary heat exchangers are designed to take heat out of the core of the reactor to the secondary heat exchangers, which then transfer the heat to steam generators for

power. Because of this design, it was a simple fire caused by the leakage of chemically reactive but non-radioactive sodium coolant. But due to the delay in shutting down of the reactor, 640kg of the sodium leaked in 3 hours and caused some unexpected damage by the fire and chemical reactions to the surrounding structure.

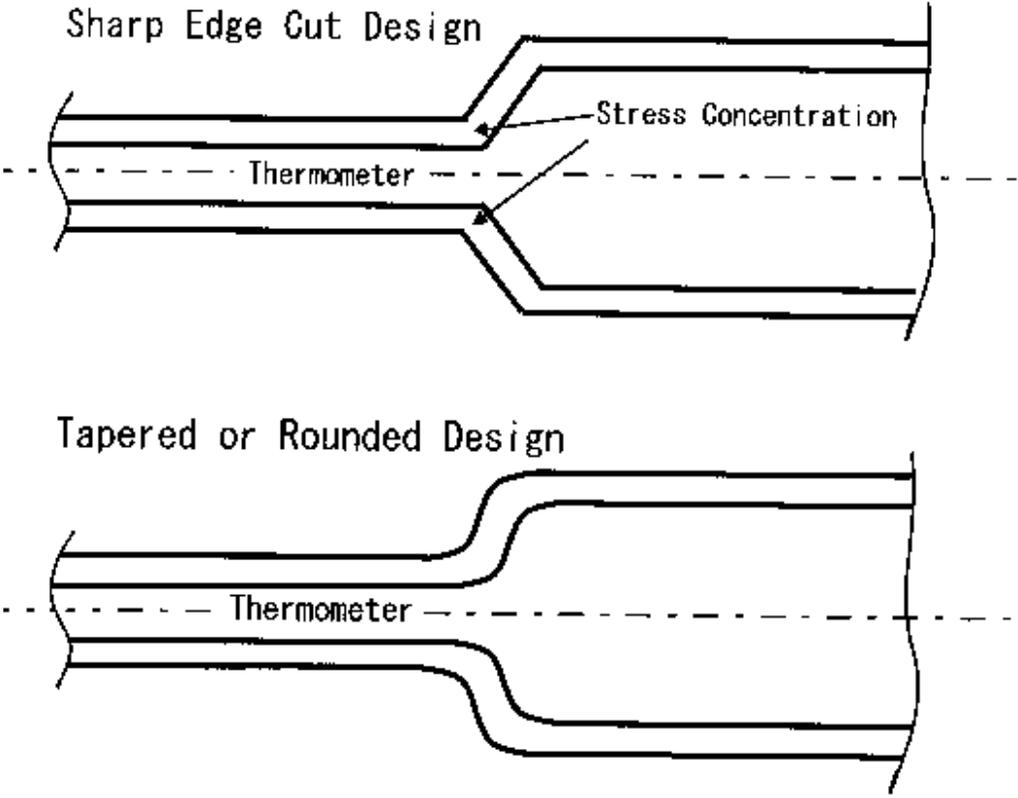
Figure 2:

Design of Broken Thermometer Sheath (Cross Section)

The sheath was found to have been broken by following design errors such as,

1. The sharp cut edge design of the sheath as shown in Fig. 2, which caused stress concentration and breakage,
2. Neglect of newly established mechanical design analysis of vibration of the sheath parallel to the sodium flow and
3. The IH company's failure to consider the fact that liquid sodium is 120 times more heat conductive than water and to use the another contractor's (the H company's) better and simpler design for those of the primary heat exchangers. See [Fig. 3](#).

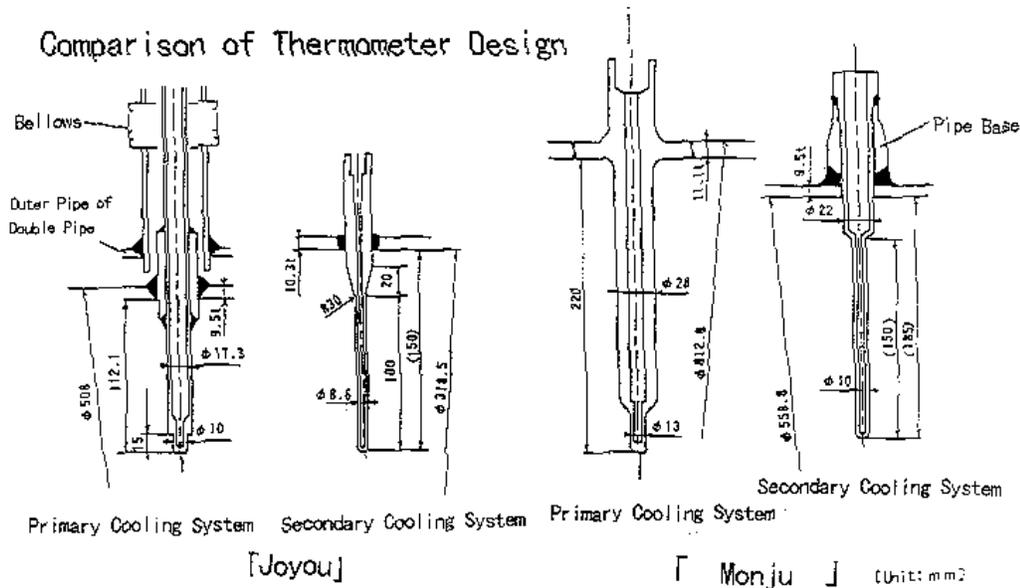
Figure 3:

Comparison of Thermometer Design
